# **Home Theatre System Service Manual**

# **MODEL: HTB-300**

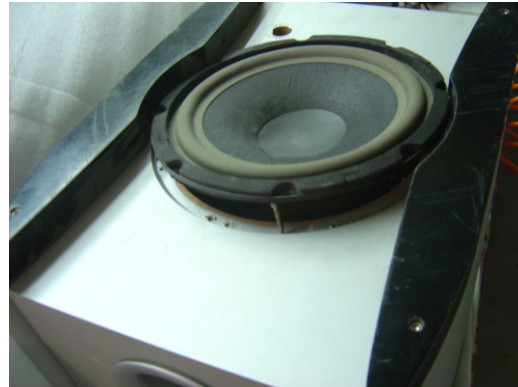
**1. Assemble woofer speaker**

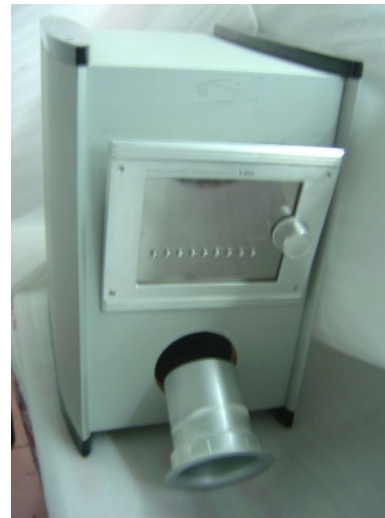
**2. Woofer flare tube**

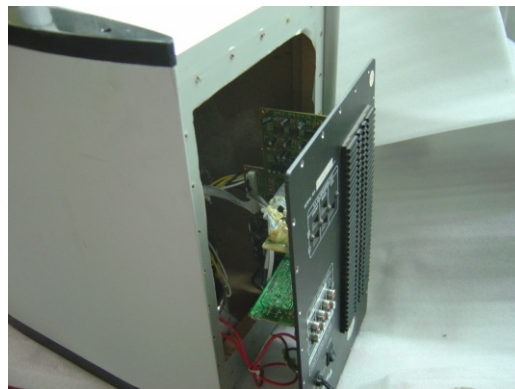
**4. Woofer rear panel**

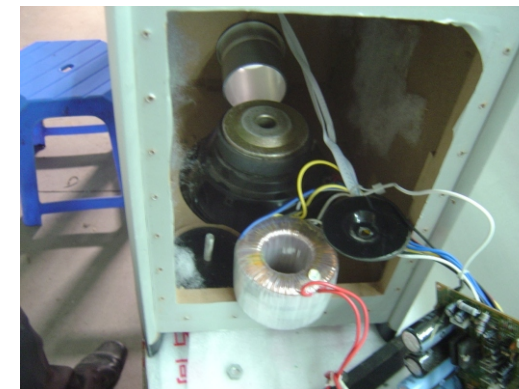
**5. Woofer transformer**
